NACA RM E52K13

# RESEARCH MEMORANDUM

PRELIMINARY INVESTIGATION IN J33 TURBOJET ENGINE OF SEVERAL  
ROOT DESIGNS FOR CERAMAL TURBINE BLADES

Lewis Flight Propulsion Laboratory  
Cleveland, Ohio

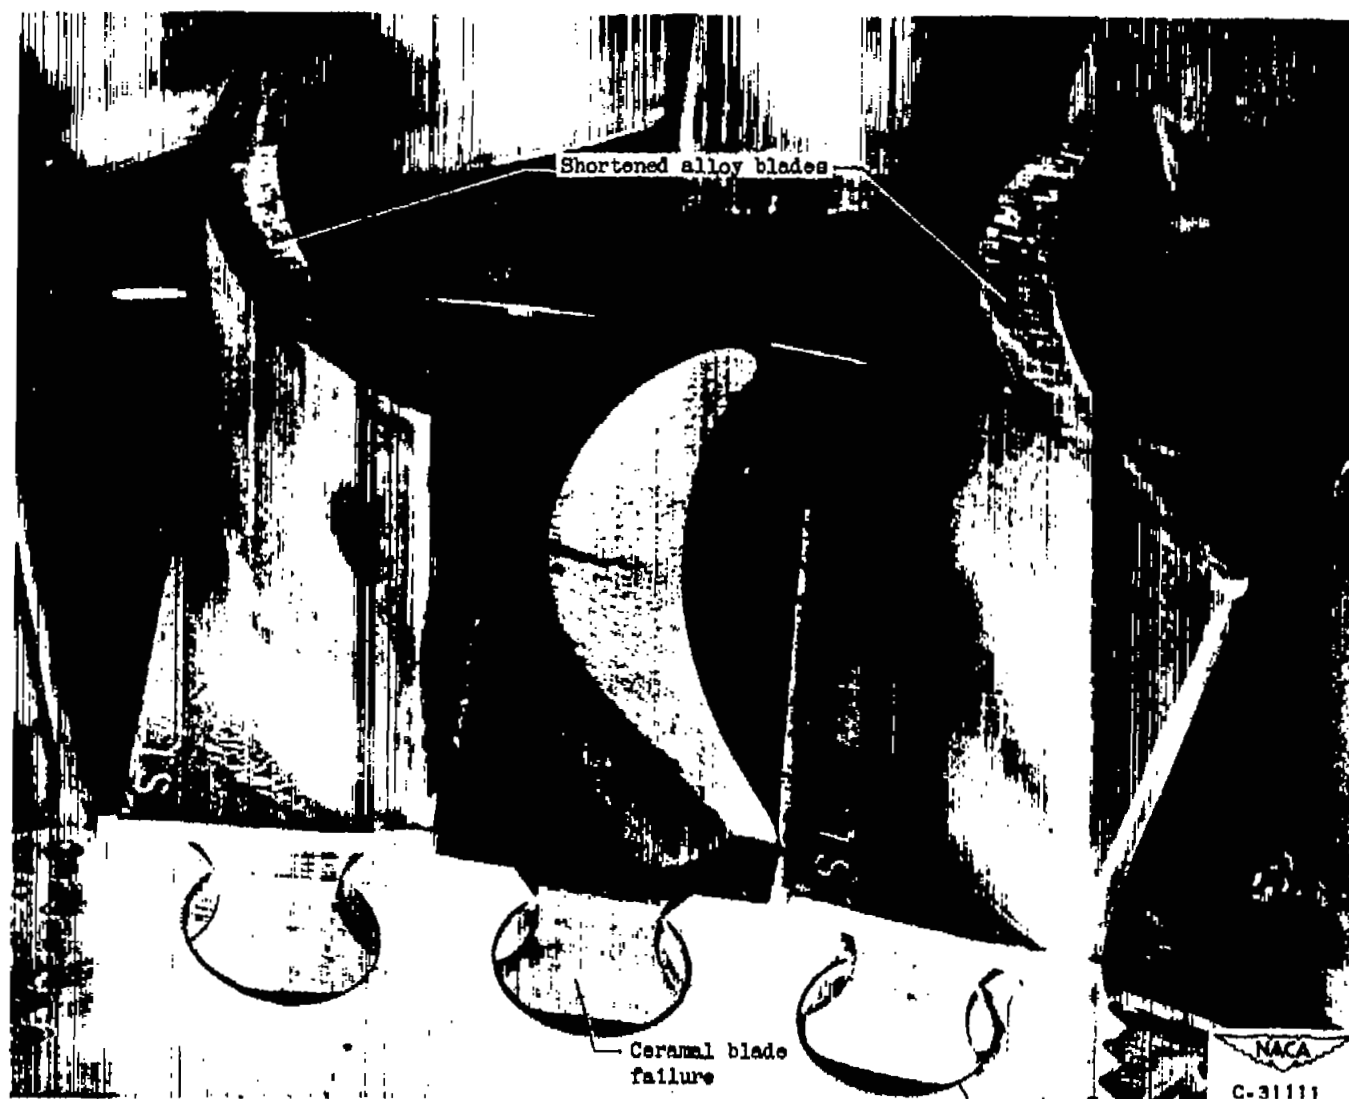
Interlock blade runs. - Runs 5 and 6 each used a single ceramal blade with two adjacent shortened alloy blades and three shortened alloy blades at diametrically opposite positions in the wheel. The gaps left in the wheels by these shortened blades apparently caused a major disturbance in the normal vibration characteristics of the engine because in each case unusually severe vibrations occurred which resulted in severe damage to the struts supporting the "bullet" in the tailcone. After run 5 these struts had a large number of cracks which were repaired by welding. After run 6 the damage was even more extensive and the struts collapsed. While it appears probable that this severe vibration caused the blade airfoil failures, the alloy blades in the remainder of the wheel experienced no apparent damage under the same conditions. A ceramal failure in these runs is shown in figure 5.

Figure 5. - Failure of ceramal blade having interlock root due to severe engine vibration.

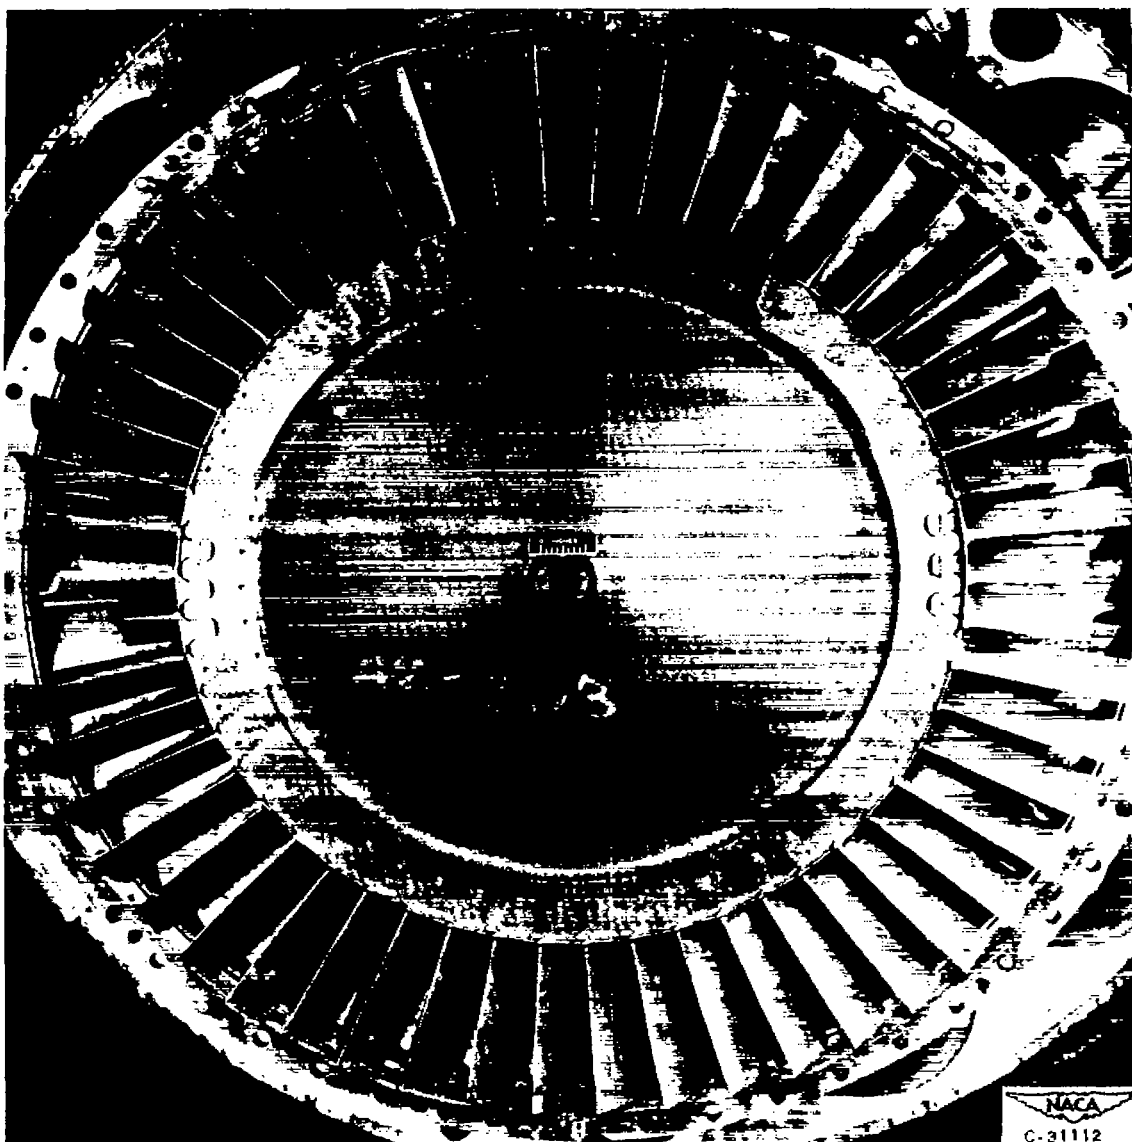
Run 7 utilized six ceramal blades and was an attempt to correct the vibration conditions of the two previous runs. The appearance of the failure (fig. 6) indicates that the first blade to fail was the one in which half the airfoil is missing. The remainder of the failures appear to have resulted from impact by fragments from the first failure. Microscopic examination of the blade that is presumed to have failed first did not reveal any defect in this blade.

During disassembly of the engine after runs 5, 6, and 7, it was noted that several of the combustion-chamber-liner positioning pins had also failed. If these failed prior to the blade failure and then passed through the turbine, their impact with the blades could account for the comparatively low time of operation of these runs.

Figure 6. - Failure of ceramal blades having interlock roots after 1 hour and 10 minutes of operation. Failure occurred at 11,370 rpm.

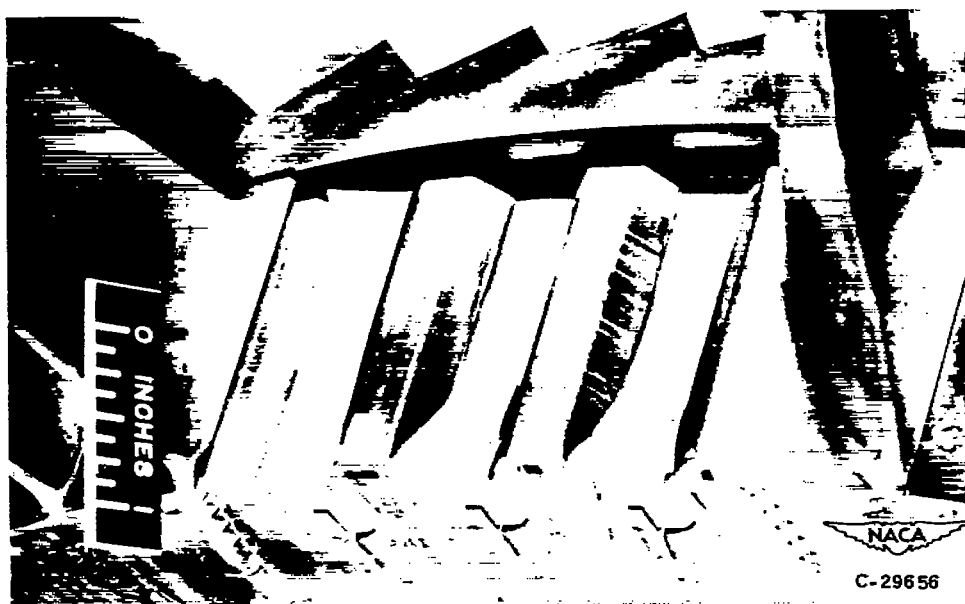
After 68 hours and 23 minutes at rated speed, failure occurred. Three of the blades on one side of the wheel failed in the root (fig. 7) while the three opposing blades (fig. 8) suffered relatively little damage. No cause for the failures could be ascertained.

Figure 7. - Failure of ceramal blades having interlock roots after 68 hours and 28 minutes of operation. Failure occurred at rated speed.

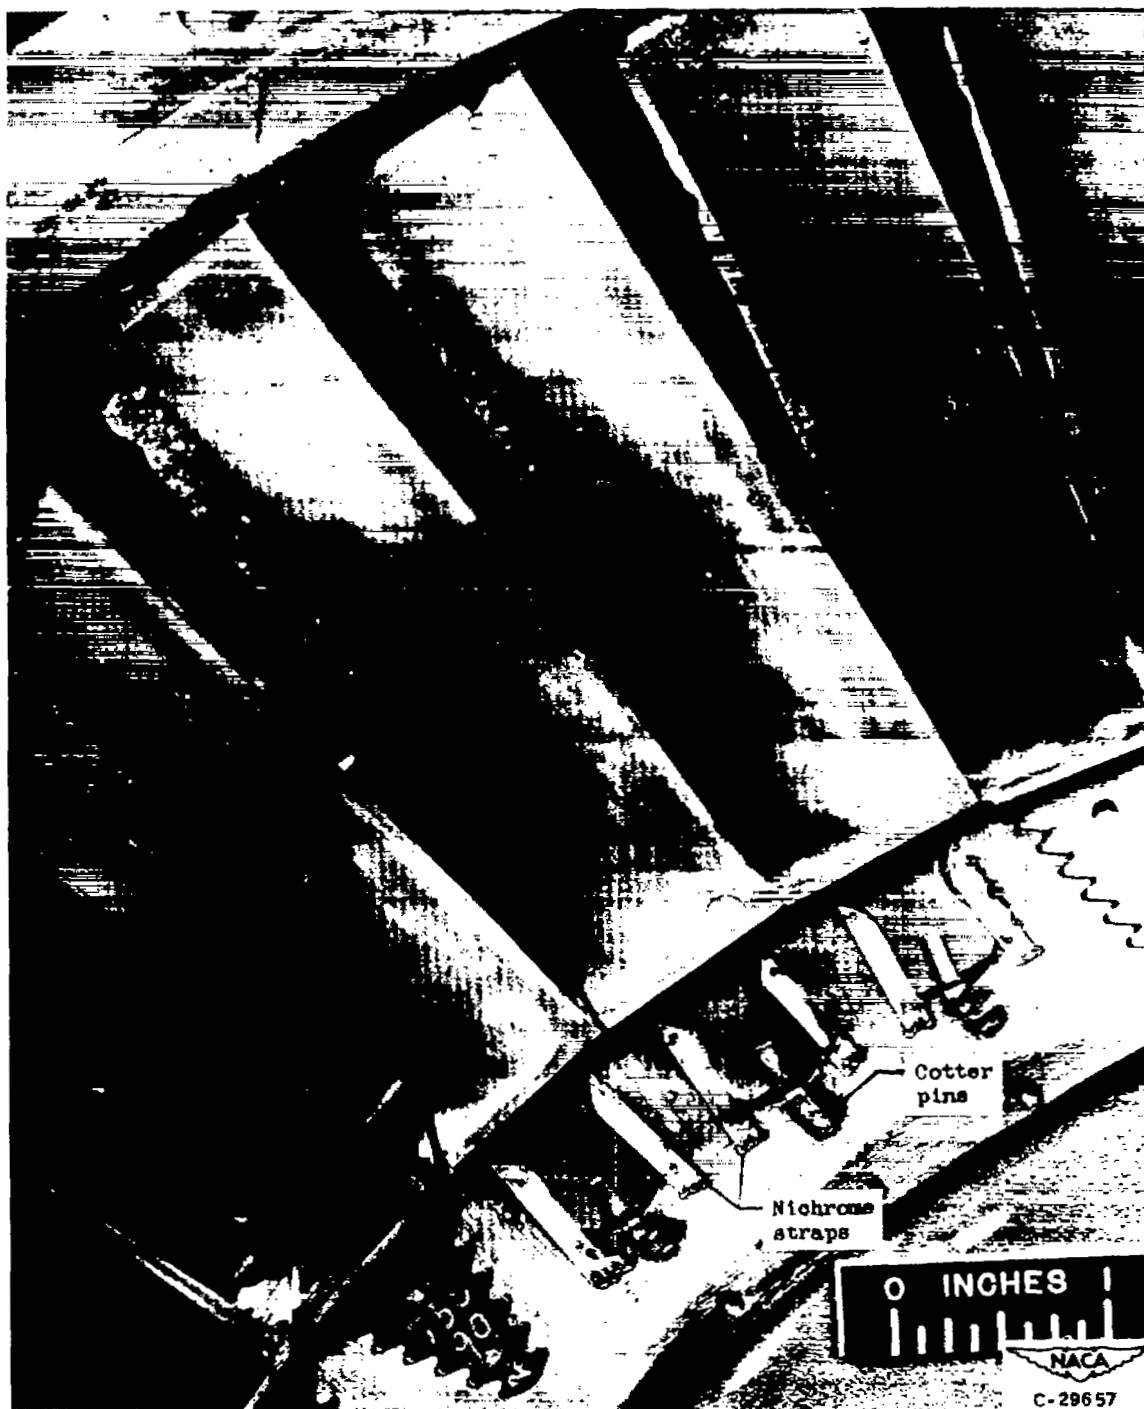
Figure 8. - Damage to ceramal turbine blades (interlock root) caused by fragments of failed ceramal turbine blade.

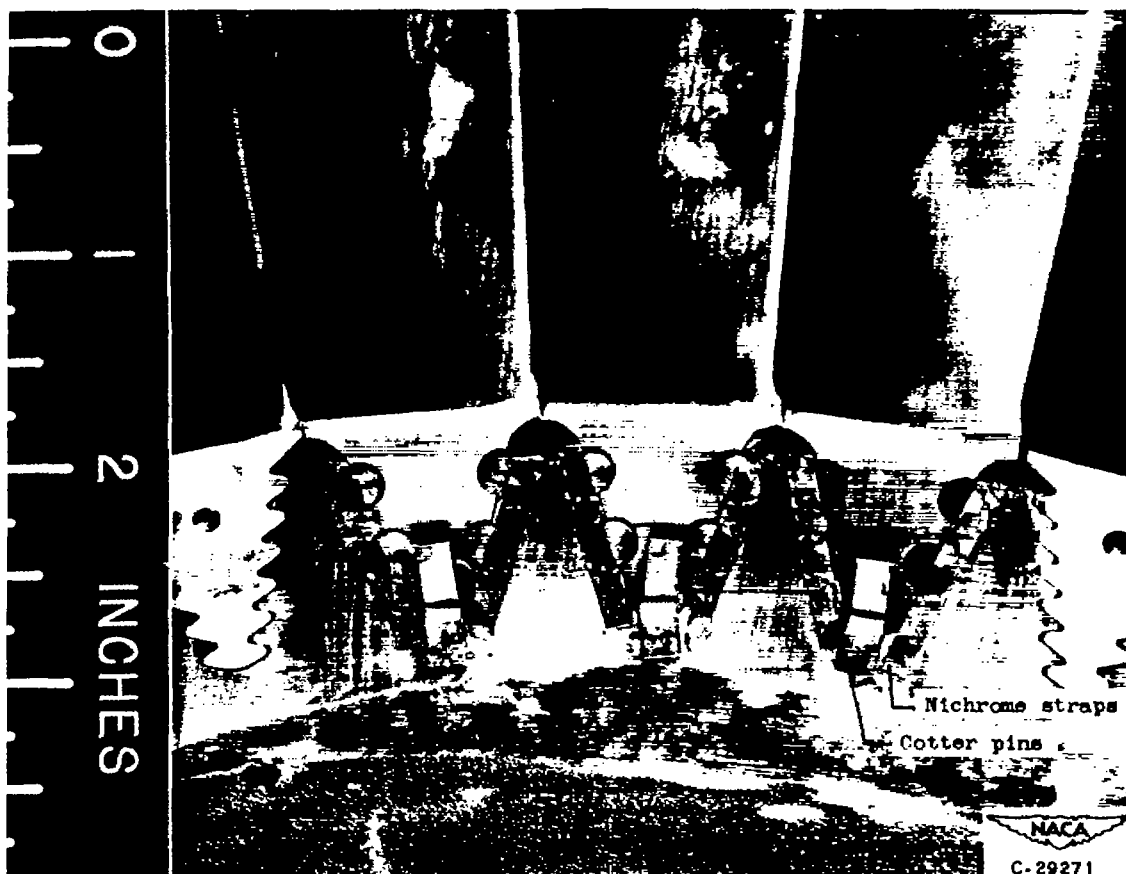
engine failed, necessitating that the engine be slowed to idle speed as rapidly as possible. After 9 hours and 42 minutes of operation (7 hr and 9 min of operation at rated conditions), the blades were all in good condition. After 19 hours and 42 minutes of operation (16 hr and 8 min at rated speed), two out of the three blades in one cluster and one out of the three blades in the other cluster were fractured across the bottom two retaining pins (fig. 10). The time these failures occurred is unknown; it appeared probable that the blade had been running in this failed condition for several hours. As the cotter pins were no longer effective in restraining the blades, a sheetmetal strap was installed across the top row of pins and operation was continued (fig. 11).

Figure 10. - Failure of ceramal blade having 4-pin root after 18 hours and 8 minutes of operation at rated speed.

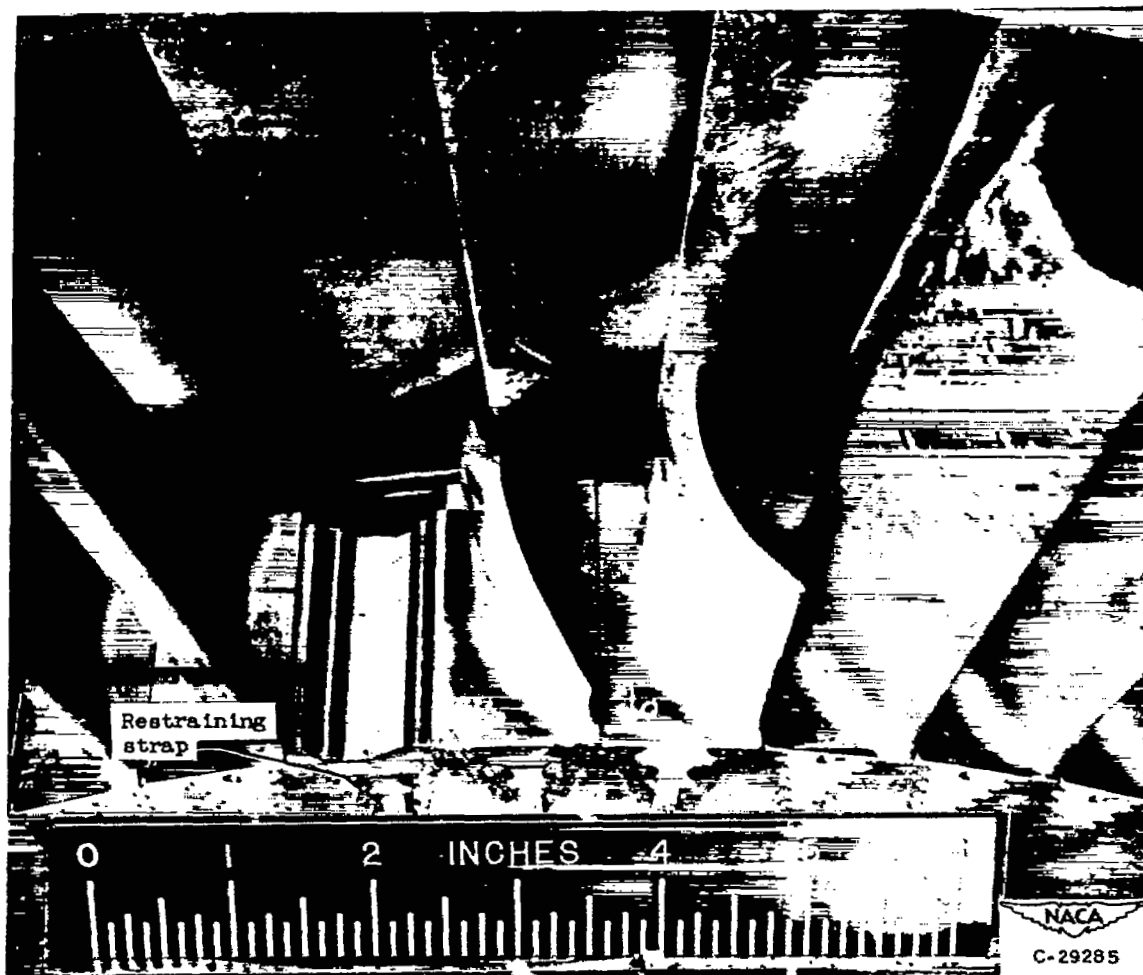
After 20 hours and 30 minutes at rated speed one blade failed across the top two pins and the fragments damaged the remaining 5 blades (fig. 8(b)). As in run 7, inspection during engine disassembly showed that several of the combustion-chamber-liner retaining pins had failed and that there had been severe damage to the aft end of the engine.

Again deformation was noted in the blade retaining pins. This deformation was slight and a softer pin material might prove more beneficial.

Figure 11. - Failure of ceramal blade having 4-pin root after 20 hours and 30 minutes of operation at rated speed.

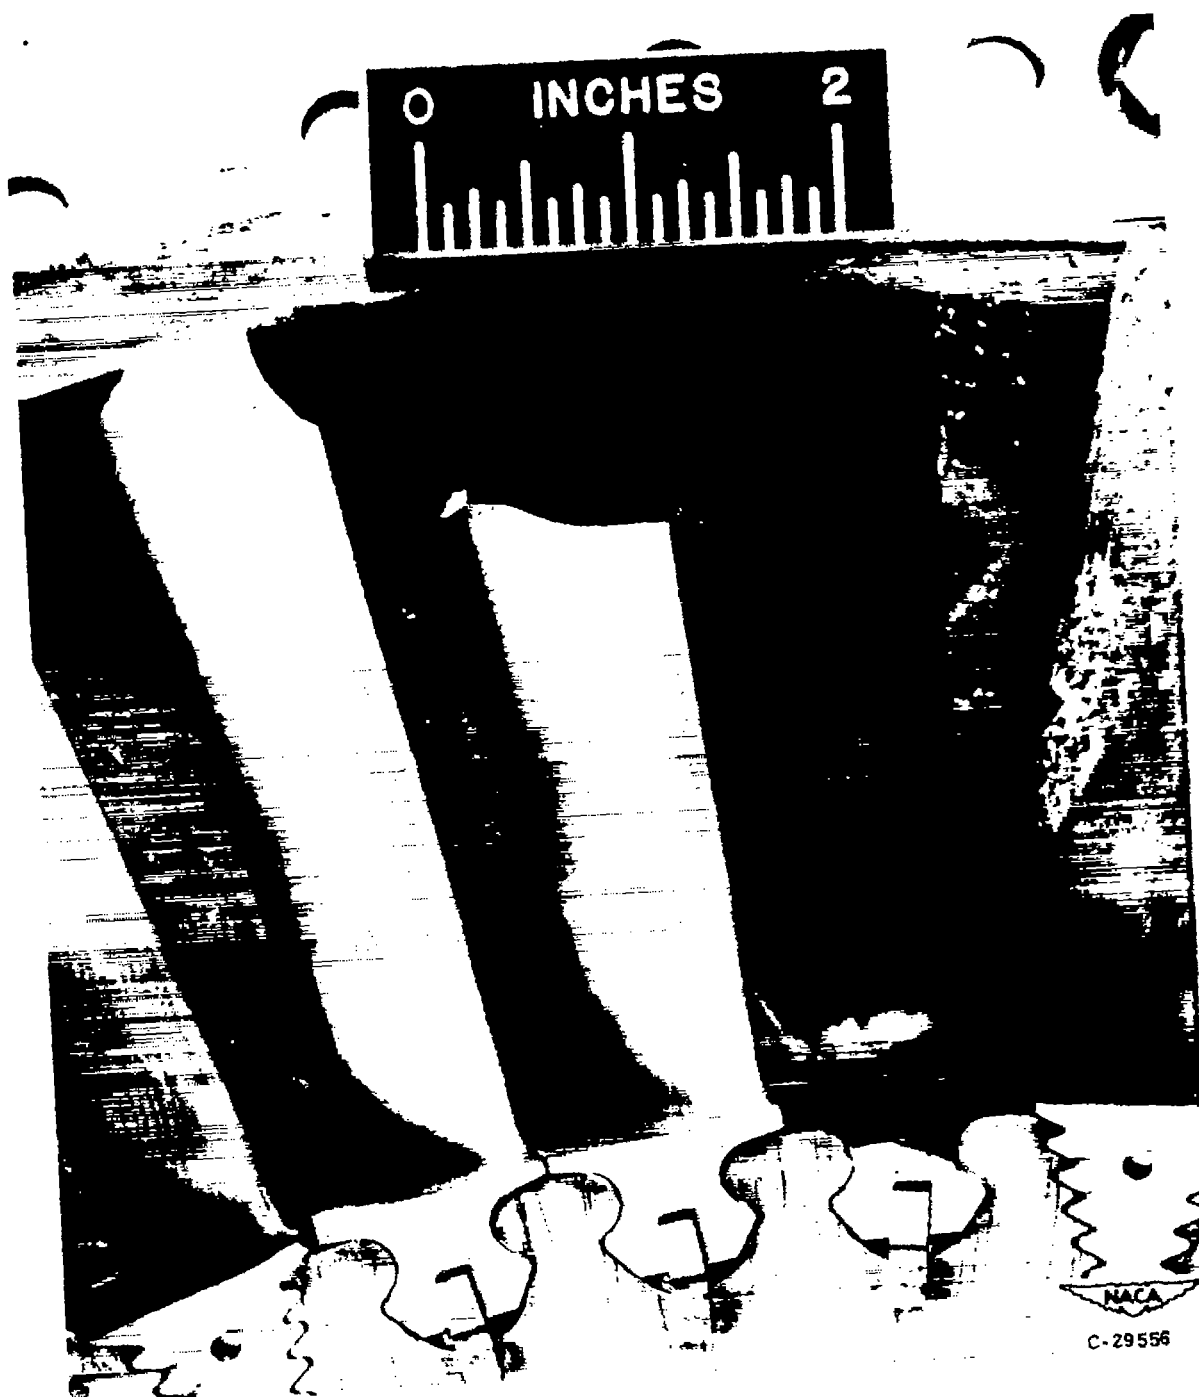
Dovetail run. - In this run mechanical failure of engine accessories necessitated three emergency shutdowns. These did not result in visible damage to the blades. After 58 hours and 28 minutes of operation at rated speed, one blade failed across the root (fig. 9) and damaged both the adjacent ceramal blades and the ceramal blades on the opposite side of the wheel, as well as several alloy blades (fig. 10). An enlarged view of this failed root is shown in figure 11. From the impression of the screen on the blade, it is evident that the screen was plastically deformed during the test. A sharp line of contact between the screen and the root can be noted in the figure. The cracks appear to follow this line. The stress concentration which caused the failure may have existed in this area.

Figure 12. - Failure of ceramic turbine blades having dovetail roots after 5 hours and 28 minutes at rated speed.

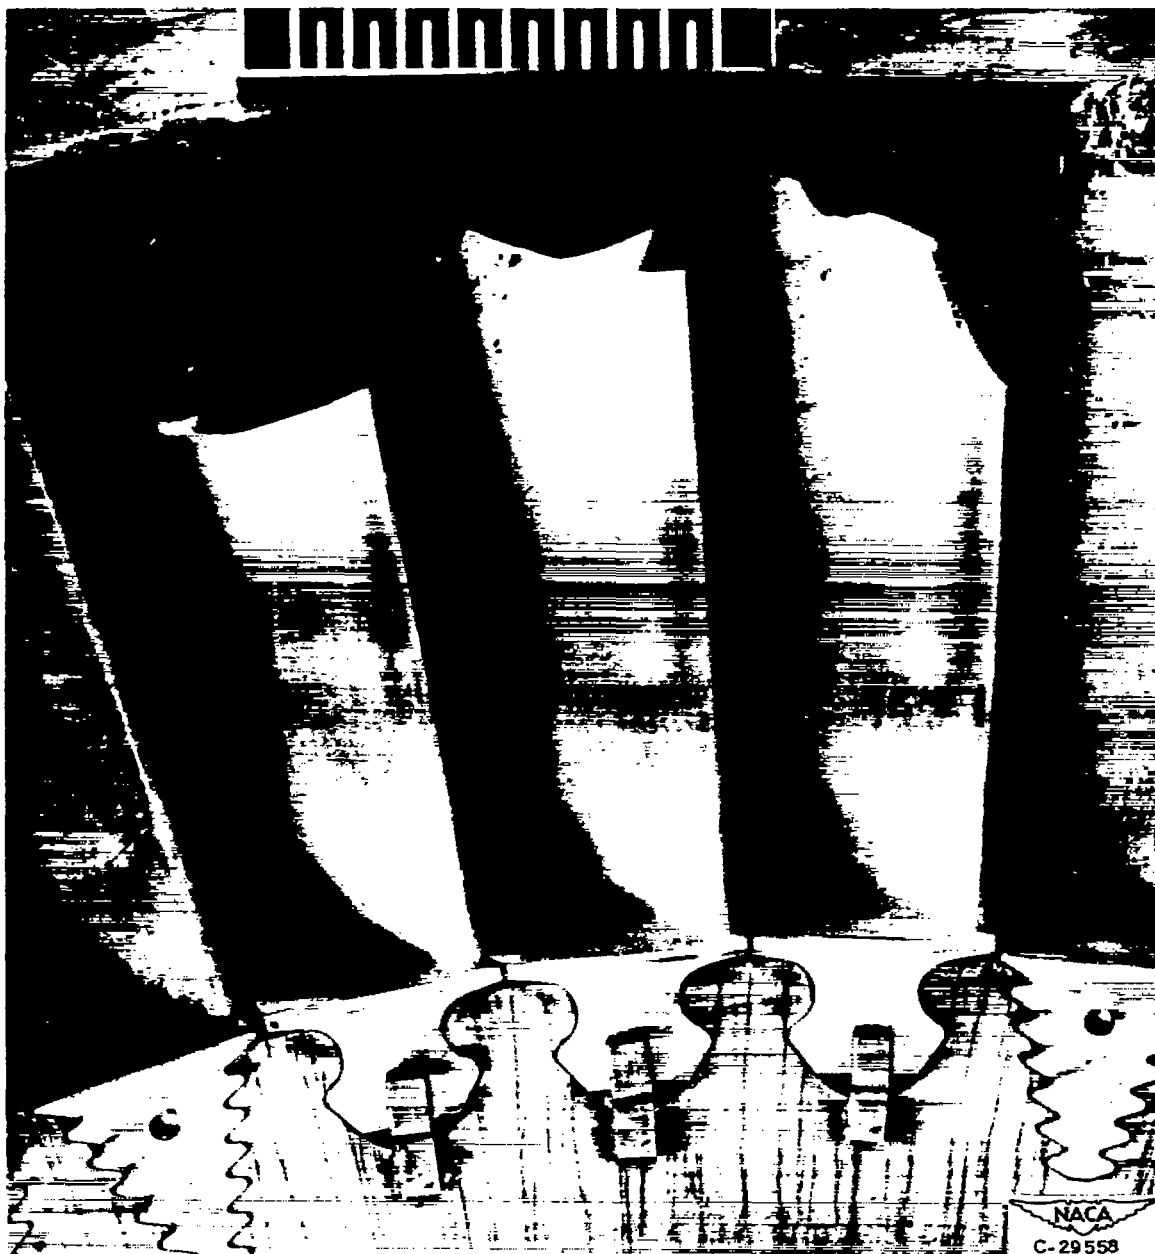
Figure 13. - Damage to ceramal turbine blades (dovetail root) caused by fragments of failed ceramal turbine blades.
